Inspection Report

Property Address:
123456 Penny Lane
sunnyville NC 90210

Q&A HOME INSPECTIONS LLC.

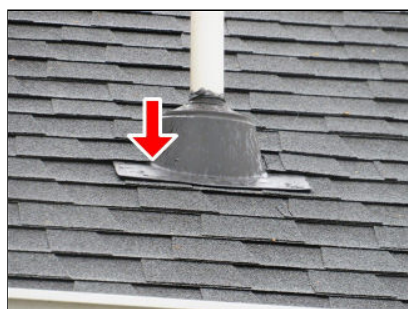
1.0 Item 1(Picture)

The flashing base for the vent was installed over the shingles and not lapped under the roof covering to shed water down the roof surface. This installation relies on caulking and will result in leaks. A licensed roofing contractor should be consulted for evaluation and repair to ensure the weather-tightness of the roof covering system.

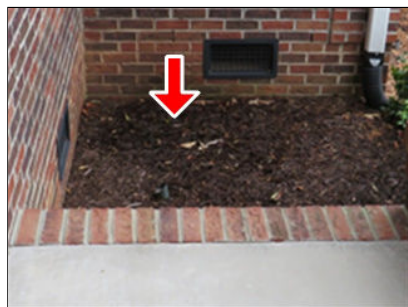
1.1 Item 1(Picture)

At the right side of the front porch, the gutter is improperly sloped (back-pitched), causing water to pool at a low point in the middle of the run rather than flowing toward the downspout. Consequently, the ground directly below this low point was saturated at the time of the inspection. This is a possible reason for several of the other moisture issues found in this 2008 home. When gutters fail to move water away, the house suffers from the ground up. Constant saturation softens the soil under the footings. This provides a possible explanation for the [gap between the brick steps] and the various [interior trim cracks] A gutter professional should evaluate and make necessary repairs to the gutter system.

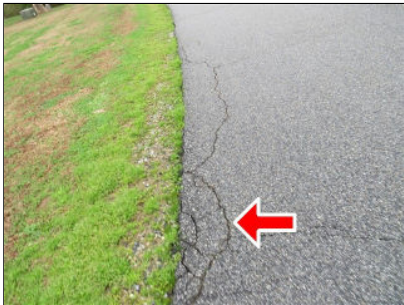
3.0 Item 1(Picture)

(1) Common cracks ($\frac{1}{4}$ -inch or less) were visible in the driveway at the time of the inspection. Cracks exceeding $\frac{1}{4}$ inch should be filled with an appropriate sealant to avoid continued damage to the driveway surface from freezing moisture.

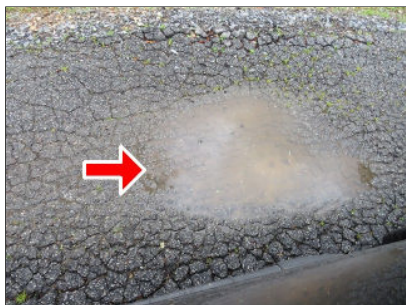
3.0 Item 7(Picture)

(2) Moderate settling visible in the driveway at the time of the inspection appeared to be due to inadequate compaction at the time of original construction. Most settling takes place in the first few years after original construction, after which settling stops and soil in the affected area becomes stable.

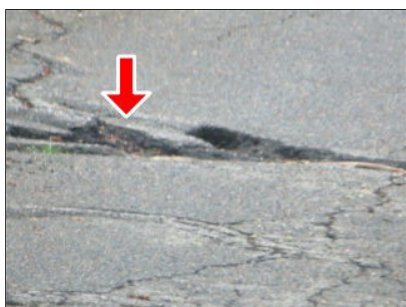
3.0 Item 8(Picture)

(3) The driveway was deteriorated and needed extensive work at the time of the inspection. The Inspector recommends you consult with a qualified contractor to discuss options and costs for repair.

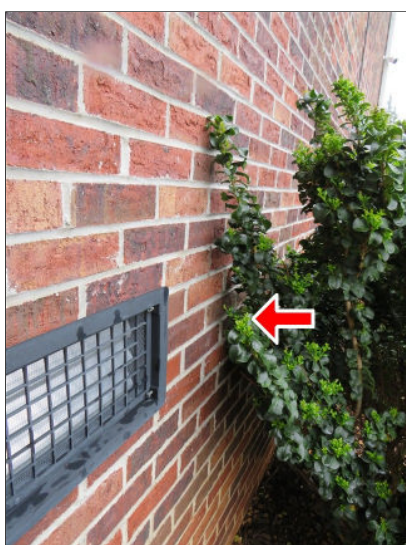
3.1 Item 1(Picture)

Vegetation growing near the rear exterior walls may introduce insects, pests and/or accelerate deterioration of the exterior wall covering by retaining moisture. Over time, vegetation may damage wall covering materials. The Inspector recommends removal of the vegetation to 1 inch from exterior walls. A qualified landscaper can do this.

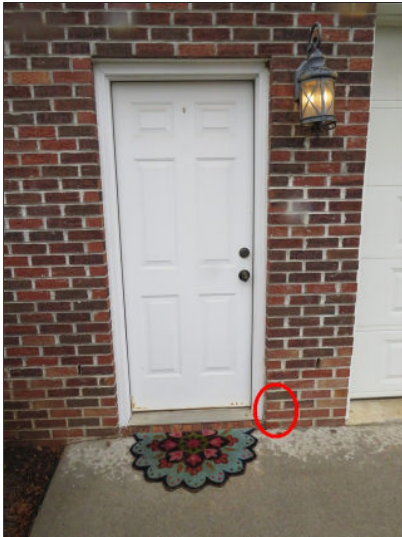
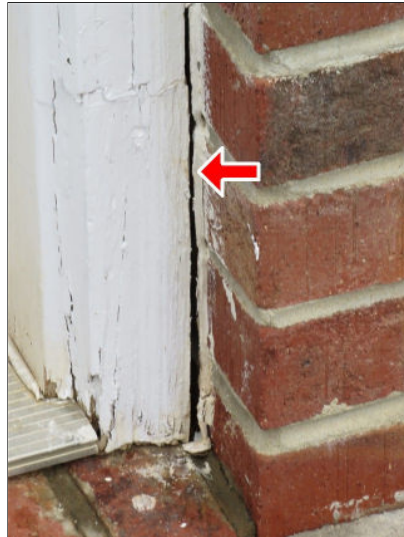
enter this gap and get trapped behind the brick veneer. Brick is a "porous" cladding that needs to breathe, but water getting behind the wood trim can cause the garage door's wood "buck" (the structural frame) to rot over time. The inspector recommends a qualified contractor Use a high-movement, exterior-grade silicone or polyurethane sealant. If the gap is deeper than 1/4 inch, a foam "backer rod" should be inserted first to provide a stable base for the sealant.

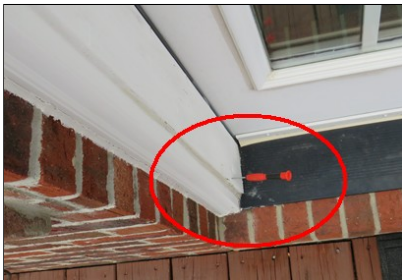
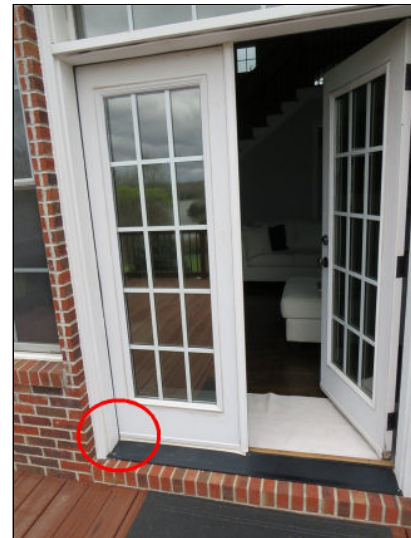
(2) The wood trim surrounding the exterior rear deck door has been repaired using a significant amount of wood putty or "filler" in place of actual wood. This is typically done to mask rot or physical damage rather than replacing the compromised material. Wood putty is not a structural material and behaves differently than natural wood. The damaged sections should be removed and replaced with PVC (composite) trim or pressure-treated wood, followed by proper flashing and high-quality exterior caulk. A qualified contractor can do this.

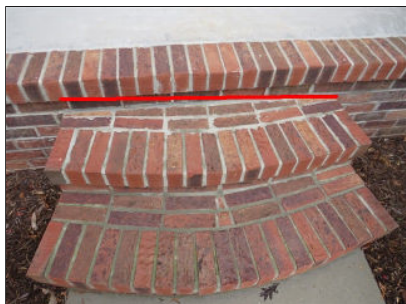
3.3 Item 1(Picture)

A separation or "gap" was observed where the brick steps meet the main structure of the brick front porch. This indicates that the steps and the porch are moving independently of one another. On a 2008 home, this type of "differential settlement" is common but needs to be monitored. This gap acts as a funnel. Rainwater running off the porch enters this opening and saturates the soil directly beneath the steps and the porch foundation. This can lead to further "sinking" and may even contribute to the [efflorescence] and [damp soil] in the crawlspace. The inspector recommends a qualified contractor:

Seal the Joint: To prevent water from making the settlement worse, the gap should be cleaned out and filled. Do not use hard mortar, as it will just crack again. Use a color-matched masonry expansion joint sealant (a flexible polyurethane) that allows for minor movement while remaining watertight.

The buyer should Mark the gap or take a precise measurement. If it widens over the next 6 months, a foundation repair specialist may need to repair as needed.

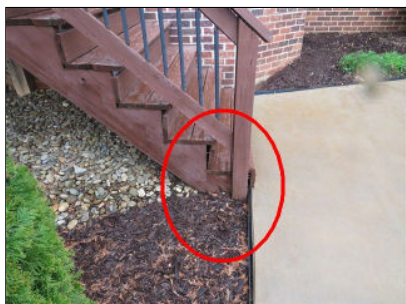
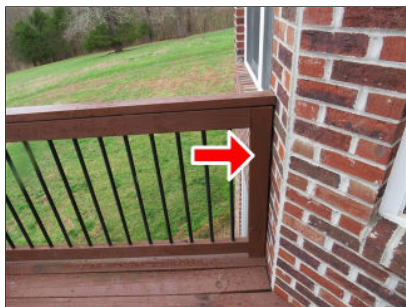
The vertical riser boards on the deck stairs are loose, and the rear guardrail system exhibits excessive movement/instability when tested with moderate pressure.

Loose risers can catch a foot during ascent or shift underfoot, leading to falls. In many jurisdictions, open risers (or loose ones) must be secured to ensure the stair stringers remain structurally "tied" together.

A licensed contractor should evaluate the whole deck structure and make all necessary repairs.

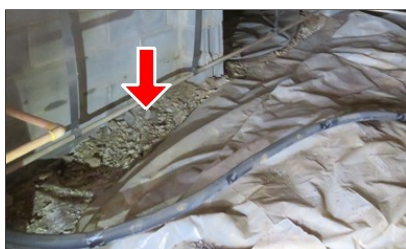
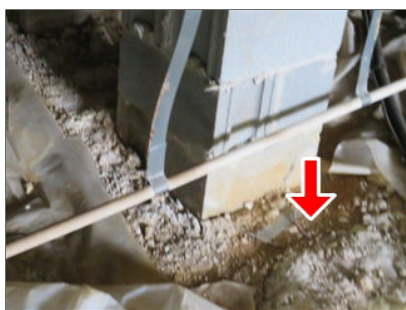
(1) The crawlspace floor is only partially covered with plastic sheeting (vapor barrier), leaving significant areas of raw soil exposed to the crawlspace atmosphere. Exposed soil allows moisture to move freely through the foundation footings and walls via capillary action. As this water evaporates, it leaves behind the [white salt deposits (efflorescence)]. Once more, High humidity levels soften the wood floor system, making it an ideal environment for wood-destroying fungi and pests like subterranean termites, which thrive in moist, dark soil. The inspector recommends existing plastic should be extended to cover 100% of the exposed soil,

the seams should be overlapped by at least 12 inches and taped with moisture-resistant tape. The plastic should also be "pipped" or fastened to the foundation walls. A qualified contractor should evaluate the crawl space vapor barrier and make all repairs as needed.

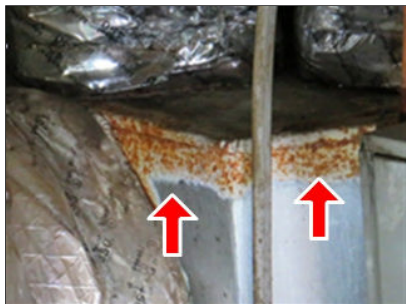
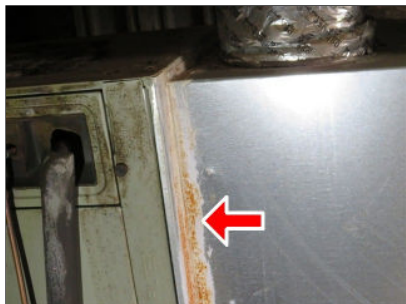
(2) The air plenum-the critical pressurized box connected directly to the HVAC unit that distributes air to the ductwork-shows visible signs of rust and corrosion. Since the units are from 2007/2009, this plenum was likely custom-fabricated at that time. Rust at the joints suggests the original sealant or "mastic" has failed. Evidence suggest this rust is a direct result of the exposed soil and [high humidity] in the crawlspace. As cold air moves through the plenum, the metal surface becomes cold; the humid crawlspace air then condenses on that metal, causing it to rust from the outside in. The inspector recommends evaluation and repair by a qualified HVAC contractor.

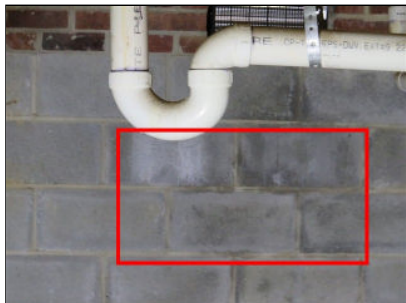
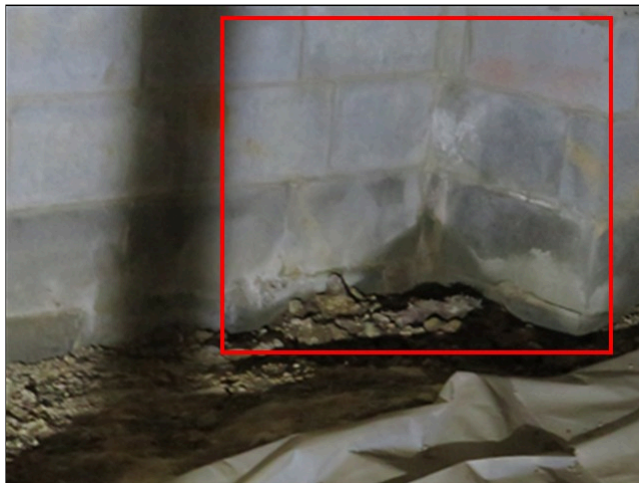
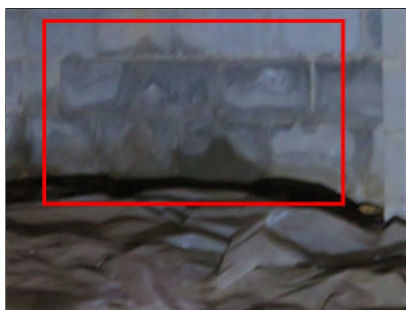
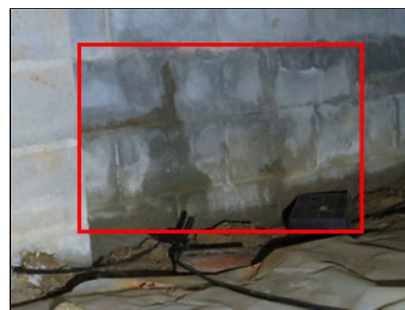
(3) White, powdery, or crystalline deposits-known as efflorescence-were observed on the interior surfaces of the Concrete Masonry Unit (CMU) foundation walls in the crawlspace. Efflorescence is a mineral salt deposit left behind when water travels through the porous concrete block and evaporates. In this 2008 home, it serves as a "historical record" of moisture intrusion. Excessively high moisture levels in soil supporting the foundation can cause various structural problems related to soil movement. The source of moisture should be identified and the condition corrected by a qualified contractor.

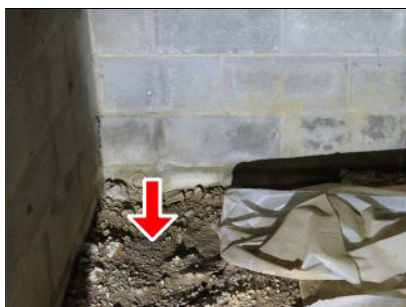
5.0 Item 10(Picture)

(4) Visible dampness or "wet look" was noted on the exposed soil in the crawlspace, yet moisture meter readings of the wood floor joists indicate low, acceptable moisture levels (typically below 12-15%). While it is a positive sign that the wood is currently dry, the damp soil remains a significant latent threat for a home. The damp soil indicates that ground moisture is actively migrating upward. Because the vapor barrier is incomplete, this moisture is evaporating into the crawlspace air. . The source of the moisture should be identified and the condition corrected by a qualified contractor.

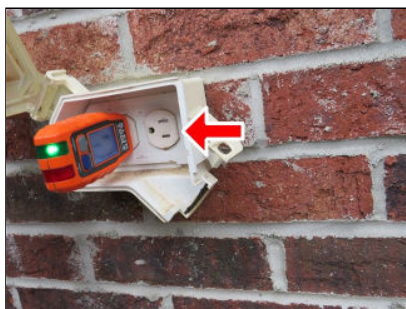
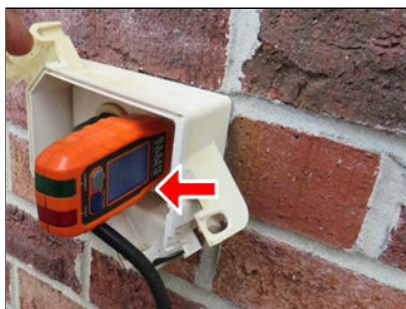
"slaved" to a master GFCI outlet elsewhere (like in the garage or a powder room). If the wires are connected to the "Line" side instead of the "Load" side of that master outlet, the porch outlet will have power but no actual protection. A licensed electrician should replace the faulty GFCI outlet or correctly wire the "downstream" protection to ensure it meets 2008 (and modern) safety standards.

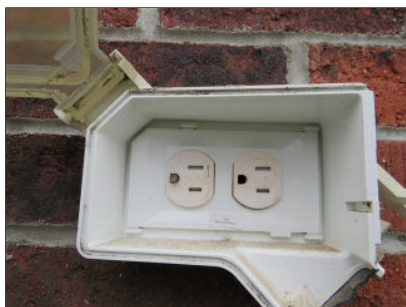
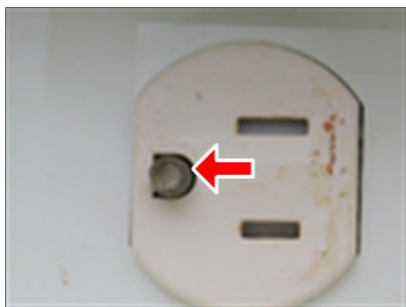
(2) The bottom outlet of the duplex receptacle on the right exterior of the home was inaccessible. A foreign object-likely a broken-off ground prong from a previous power cord-is lodged inside the equipment ground (circular) hole. Consequently, the inspector was unable to insert a tester to verify the wiring or GFCI functionality of the bottom half of the outlet. This is a functional defect that presents a clear safety hazard. Because this outlet could not be tested, the inspection of this receptacle was incomplete. the inspector recommends this receptacle should be replaced by a qualified electrical contractor rather than repaired

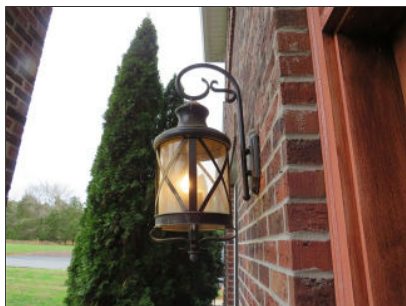
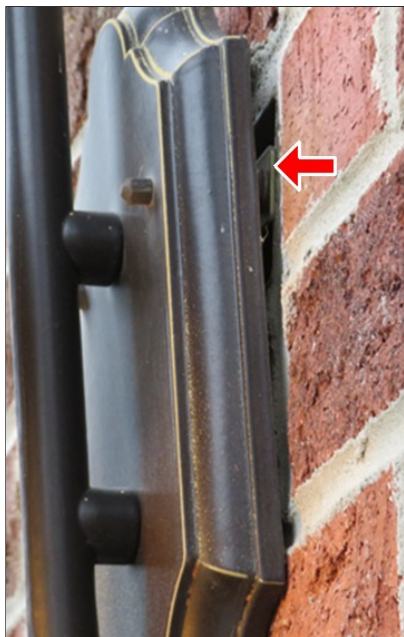
The left exterior light fixture at the front porch is not securely fastened to the mounting box or the wall surface. It exhibits movement when touched or during windy conditions. A loose fixture creates a gap between the light and the wall. Rainwater can enter the electrical box, leading to short circuits, corrosion of the wiring. A qualified electrician should tighten the mounting screws or nuts that hold the fixture to the bracket. If the bracket is loose, it must be re-secured to the electrical box.

Note: Always leave the very bottom unsealed to allow any internal condensation to drain

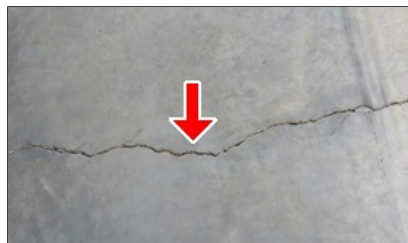
7.0 Item 1(Picture)

(1) Moderate cracking was visible in the garage floor at the time of the inspection. This type of cracking is typically caused by soil movement. The Inspector recommends evaluation by a structural engineer to determine the degree to which this condition is likely to continue and to discuss options for correction or stabilization.

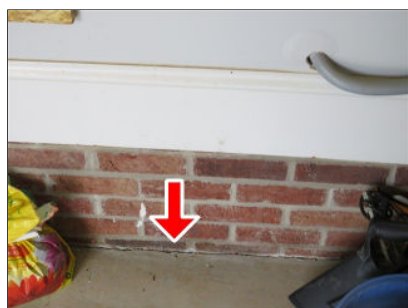
7.0 Item 2(Picture)

(2) A visible gap or "separation joint" was observed where the concrete garage floor slab meets the perimeter foundation walls. The inspector recommends a qualified person fill the gap with a high-quality, self-leveling polyurethane masonry sealant. This remains flexible as the slab moves seasonally, maintaining an airtight and watertight seal.

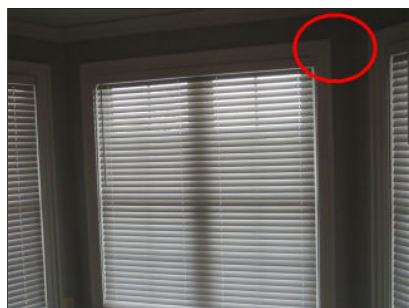
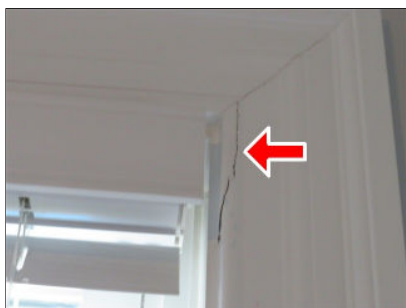
(1) A visible crack was identified at the upper corner of the window trim (casing) in the upstairs left-rear bedroom. Much like the [cracked crown molding] found at the doorway, this window trim crack is a symptom of movement. In an 18-year-old home, window corners are high-stress points where structural loads and thermal changes. The inspector recommends a qualified person apply a flexible style caulk, and touch up with paint. You should monitor crack for any movement.

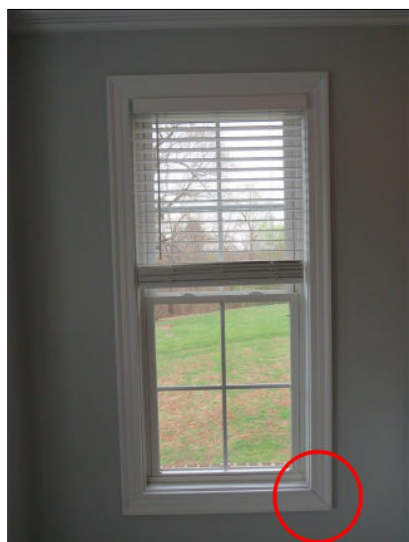
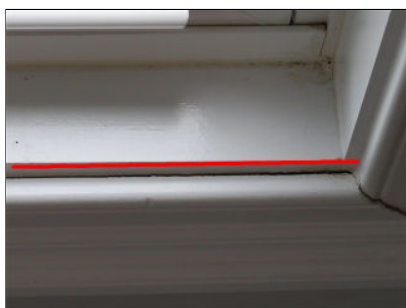
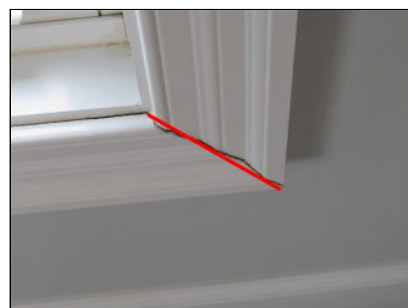
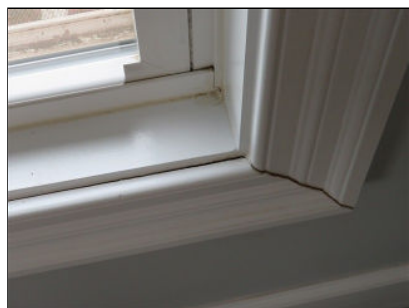
(2) A visible gap was noted at the bottom trim (sill or apron) of the master bedroom window. The trim appears to have pulled away from either the window frame and drywall. : In an 18-year-old home, a gap at the bottom of a window is often more concerning than a crack at the top, as it is a common indicator of moisture or structural "pulling." The inspector recommends monitoring this area for movement. If crack widening occurs a structural engineer should be called for an evaluation of the foundation system.

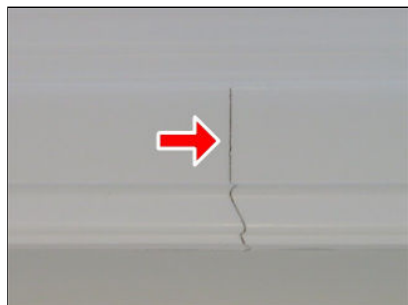
8.2 Item 1(Picture)

The crown molding located above an upstairs doorway exhibits visible cracking. This is usually visual indicator of movement within the home's structure. This is very common in 2-story homes. In the winter, the top chords of the roof trusses dry out and shrink while the bottom chords (buried in insulation) stay warm. This causes the truss to "arch" upward, pulling the ceiling away from the interior walls and cracking the molding.. The inspector recommends monitoring this area for movement. If crack widening occurs a structural engineer should be called for an evaluation of the foundation system.

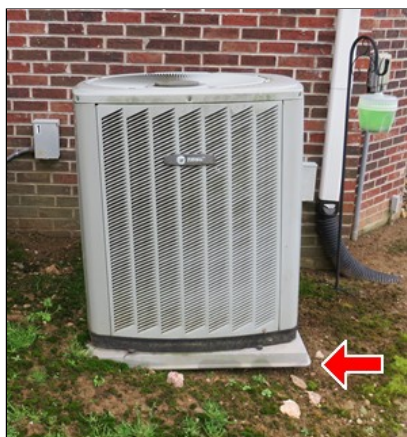
11.0 Item 1(Picture)

(1) The exterior HVAC condenser unit was found to be unlevel, exhibiting a noticeable lean. The condenser fan motor is designed to spin on a perfectly vertical or horizontal axis. A lean creates uneven centrifugal force on the bearings, leading to the noisy fan motor we often see in aging units. Also, most units are designed to allow rainwater or defrost-cycle condensation to drain out of the base. A lean can cause water to pool inside the cabinet, accelerating the rusting of the air handler/cabinet. An HVAC technician should evaluate and repair as needed.

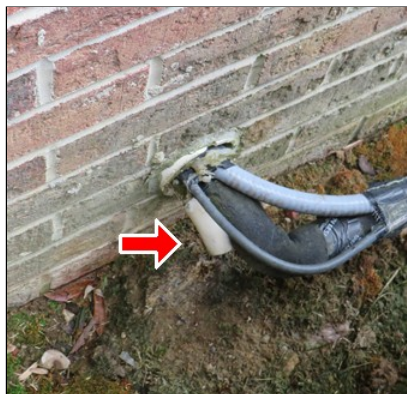
11.0 Item 2(Picture)

(2) The condensate line is dumping directly next to the foundation. Prolonged concentrated exposure to water this close to the foundation can lead to more serious problems. The water needs to be directed away from the foundation. A general repair person can fix this.

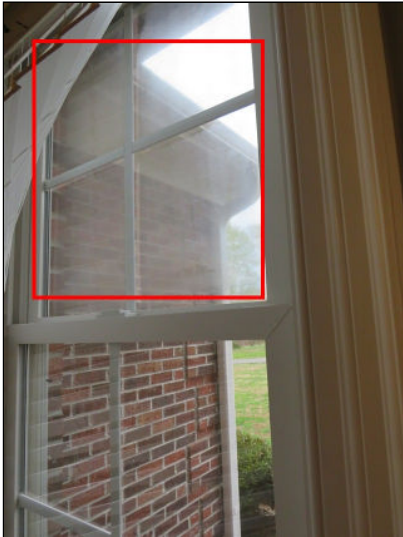
12.0 Item 1(Picture)

Although no condensation was visible at the time of the inspection, staining and etching of the glass at a window in the main floor hallway bathroom indicated a loss of thermal integrity. Etching of the glass from long-term exposure to condensation constitutes permanent damage. The Inspector recommends you consult with a qualified contractor to discuss options and costs for replacement.

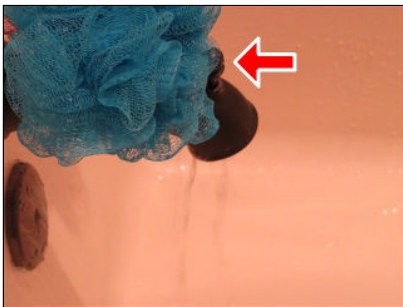
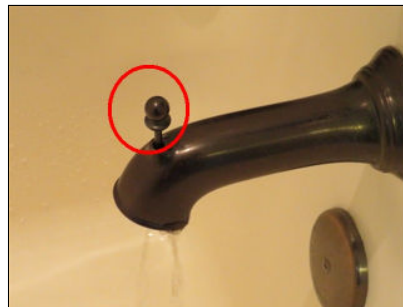
(1) The tub spout diverter at the upstairs and main floor hallway bathroom was observed to be [leaking] when engaged. A faulty diverter causes water to discharge from the tub spout while the shower is in use, resulting in reduced water pressure at the showerhead and significant water waste. Over time, the internal gate or washer can become corroded or mineral-clogged, eventually preventing the shower from functioning entirely. The inspector recommends that a licensed plumber or qualified handyman replace the tub spout or repair the diverter mechanism to ensure proper water distribution and pressure.

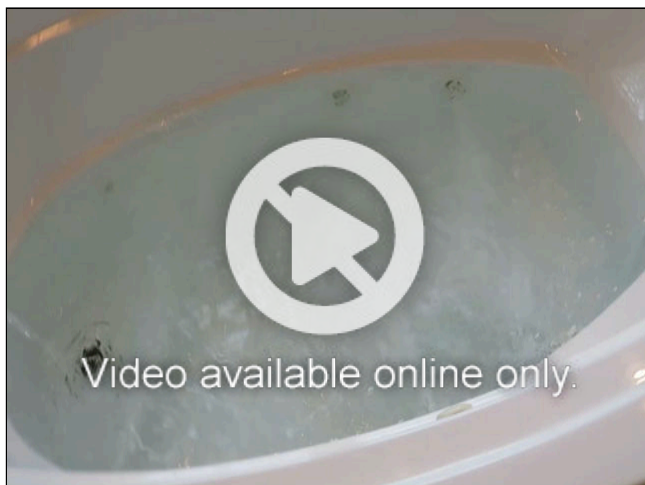
12.1 Item 3(Video)

(2) The jets in the master bathroom ejected debris into the water when they were activated. The Inspector recommends that the system be serviced by a qualified plumbing contractor or technician.

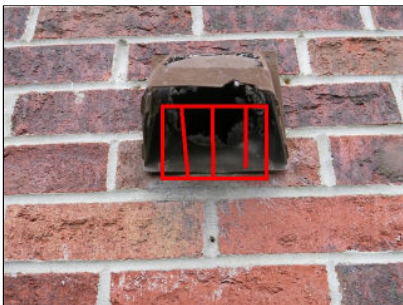
14.1 Item 1(Picture)

The dryer vent was missing the exterior cover or screen. This condition may allow animal entry or the accumulation of debris related to animal nesting. The inspector recommends installation of a proper cover by a qualified contractor.
