Inspection Report

Property Address:
123456 Penny Lane
sunnyville NC 90210

Q&A HOME INSPECTIONS LLC.

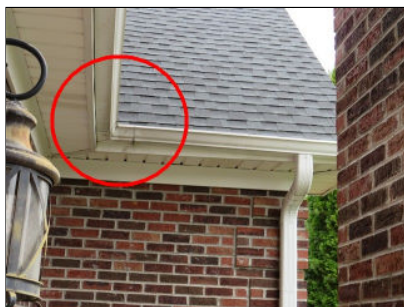
1.1 Item 2(Picture)

At the right side of the front porch, the gutter is improperly sloped (back-pitched), causing water to pool at a low point in the middle of the run rather than flowing toward the downspout. Consequently, the ground directly below this low point was saturated at the time of the inspection. This is a possible reason for several of the other moisture issues found in this 2008 home. When gutters fail to move water away, the house suffers from the ground up. Constant saturation softens the soil under the footings. This provides a possible explanation for the [gap between the brick steps] and the various [interior trim cracks] A gutter professional should evaluate and make necessary repairs to the gutter system.

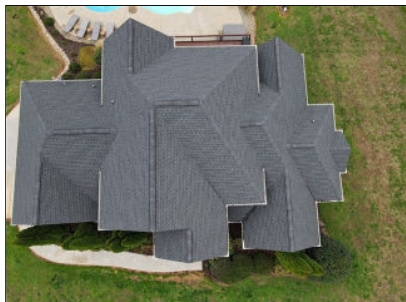
1.2 Item 1(Picture)

In North Carolina, a roof replacement typically requires a permit. You'll want to verify if the work was permitted and if the manufacturer's warranty is transferable to the new owner.

The inspector recommends asking the seller for the installation date, the contractor's name, and the shingle brand/series.

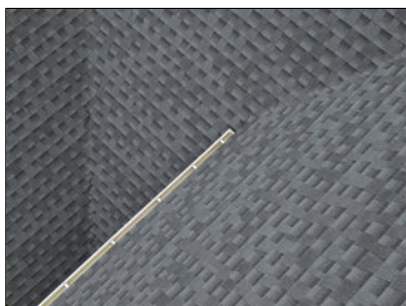
1.2 Item 2(Picture)

(2) The roof was covered with architectural fiberglass asphalt shingles, also called "laminated" or "dimensional" shingles. Architectural shingles are composed of multiple layers bonded together. Fiberglass shingles are composed of a fiberglass mat embedded in asphalt and covered with ceramic-coated mineral granules. Shingles with multiple layers bonded together are usually more durable than shingles composed of a single layer.

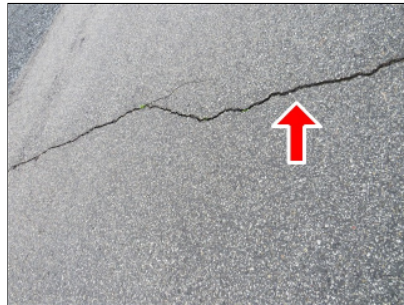
3.0 Item 2(Picture)

(1) Common cracks ($\frac{1}{4}$ -inch or less) were visible in the driveway at the time of the inspection. Cracks exceeding $\frac{1}{4}$ inch should be filled with an appropriate sealant to avoid continued damage to the driveway surface from freezing moisture.

(2) Moderate settling visible in the driveway at the time of the inspection appeared to be due to inadequate compaction at the time of original construction. Most settling takes place in the first few years after original construction, after which settling stops and soil in the affected area becomes stable.

(3) The driveway was deteriorated and needed extensive work at the time of the inspection. The Inspector recommends you consult with a qualified contractor to discuss options and costs for repair.

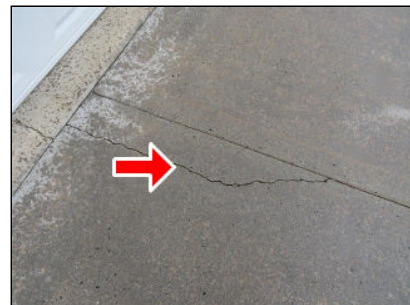
3.0 Item 6(Picture)

(2) Moderate settling visible in the driveway at the time of the inspection appeared to be due to inadequate compaction at the time of original construction. Most settling takes place in the first few years after original construction, after which settling stops and soil in the affected area becomes stable.

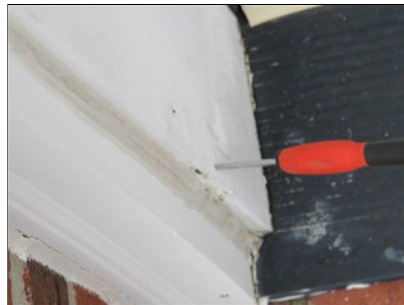
3.2 Item 4(Picture)

(2) The wood trim surrounding the exterior rear deck door has been repaired using a significant amount of wood putty or "filler" in place of actual wood. This is typically done to mask rot or physical damage rather than replacing the compromised material. Wood putty is not a structural material and behaves differently than natural wood. The damaged sections should be removed and replaced with PVC (composite) trim or pressure-treated wood, followed by proper flashing and high-quality exterior

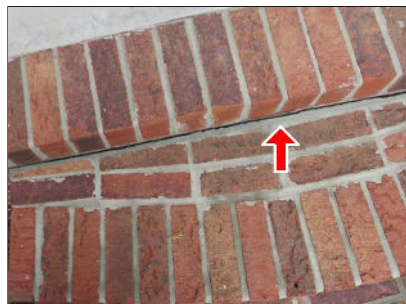
3.3 Item 2(Picture)

A separation or "gap" was observed where the brick steps meet the main structure of the brick front porch. This indicates that the steps and the porch are moving independently of one another. On a 2008 home, this type of "differential settlement" is common but needs to be monitored. This gap acts as a funnel. Rainwater running off the porch enters this opening and saturates the soil directly beneath the steps and the porch foundation. This can lead to further "sinking" and may even contribute to the [efflorescence] and [damp soil] in the crawlspace. The inspector recommends a qualified contractor:

Seal the Joint: To prevent water from making the settlement worse, the gap should be cleaned out and filled. Do not use hard mortar, as it will just crack again. Use a color-matched masonry expansion joint sealant (a flexible polyurethane) that allows for minor movement while remaining watertight.

The buyer should Mark the gap or take a precise measurement. If it widens over the next 6 months, a foundation repair specialist may need to repair as needed.

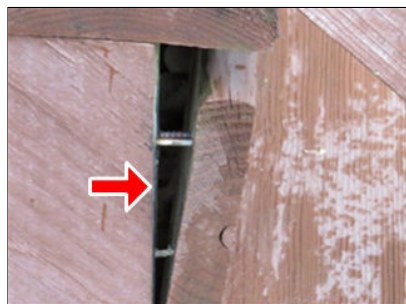
3.4 Item 2(Picture)

The vertical riser boards on the deck stairs are loose, and the rear guardrail system exhibits excessive movement/instability when tested with moderate pressure.

Loose risers can catch a foot during ascent or shift underfoot, leading to falls. In many jurisdictions, open risers (or loose ones) must be secured to ensure the stair stringers remain structurally "tied" together.

A licensed contractor should evaluate the whole deck structure and make all necessary repairs.

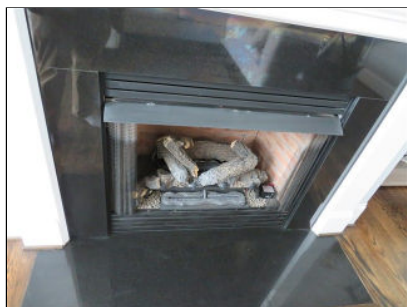
10.2 Item 1(Picture)

The standing pilot light for the gas fireplace was not lit at the time of inspection, preventing the unit from being tested for functional operation. Because the pilot was out, the main burner, the thermopile/thermocouple (safety sensors), the gas valve, and the [remote/wall switch] could not be evaluated. It is impossible to tell if the unit is "simply off" or if it has a mechanical failure. You ask the seller to light the pilot and provide instructions. If the seller is unable to light it, it should be considered "Inoperable." and a qualified HVAC contractor should evaluate and repair.

You should insure a working Carbon Monoxide (CO) detector is present.

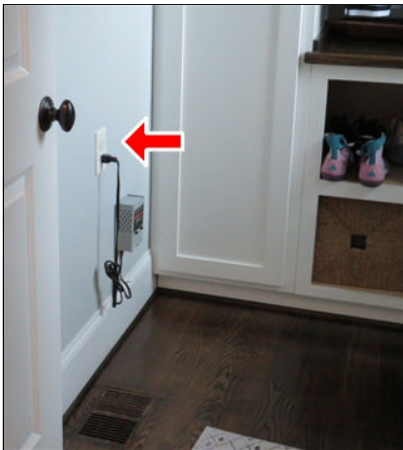
14.0 Item 1(Picture)

Electrical receptacles in the laundry room had no Ground Fault Circuit Interrupter (GFCI) protection. Although this condition may have been considered acceptable at the time the home was originally constructed, as knowledge of safe building practices has improved with the passage of time, building standards have changed to reflect current understanding. Consider having GFCI protection installed as a safety precaution for receptacles within 6 feet of a plumbing fixture. This can be achieved by:

1. Replacing the current standard electrical receptacles with GFCI outlets;
2. Replacing the electrical receptacle nearest the overcurrent protection devices (breakers or fuses) protecting laundry room circuits with a GFCI receptacle; or
3. Replacing the breakers currently protecting the electrical circuits in the Laundry room with GFCI breakers.
